# Customer Testimonial

Product Name: Viper WRL Mid Kit

Location: Melbourne Port, Australia

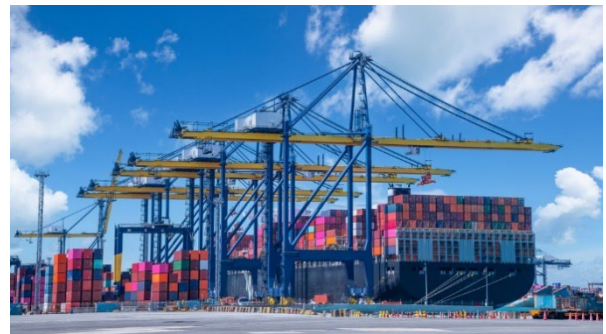
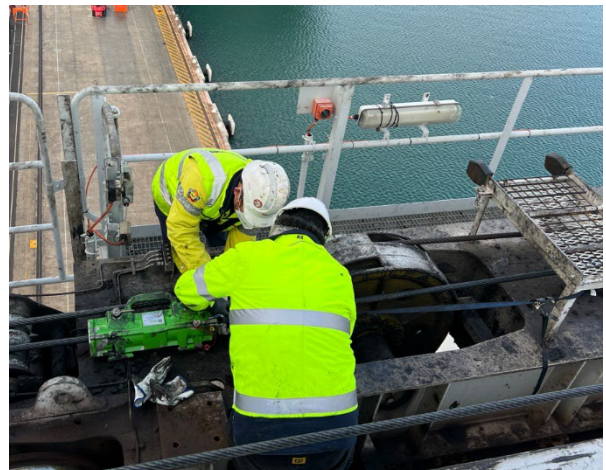
FIG 1 – Maintenance team safely cleaning and lubricating boom rope in a single pass in just under an hour.

By using the Viper WRL Mid Kit along with the Viper VRC (Viper Rope Cleaner), a team of three can effectively clean the wire ropes, remove contaminants, and re-lubricate at normal operating speeds. (Ref FIG 1) it took one hour to clean and lubricate a boom rope.

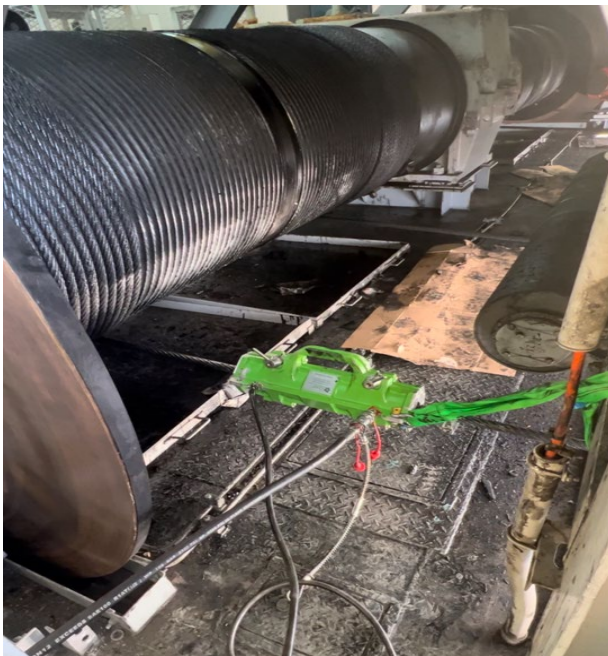
FIG 2 – Viper WRL Mid is set up in the drum wire room, cleaning and applying new Viper Wire Coating Grease whilst rope is feeding back onto the drum.

In addition to the time saving benefits, the application of Viper Coating Grease resulted in consistent lubrication of the wire ropes. This has ensured that the ropes are coated evenly with a fresh layer of lubricant. (Ref FIG 2 & 3).

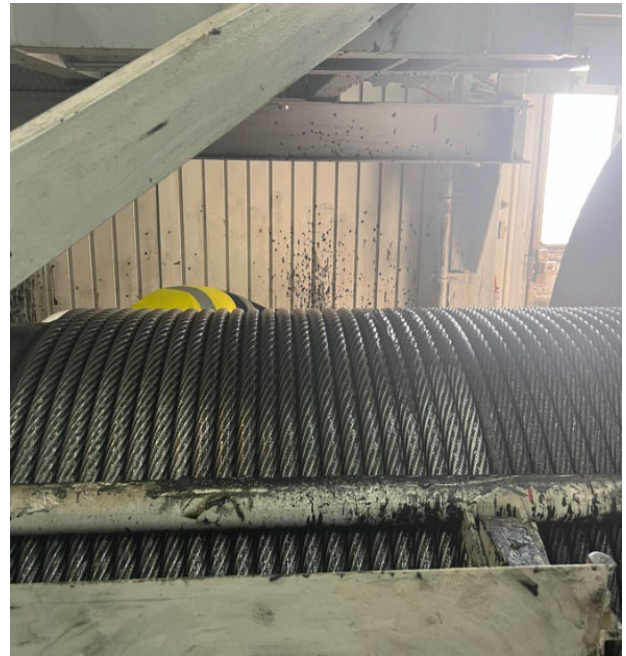
FIG 3 – Visually you can see the left-hand side of the drum has cleaned and re-lubricated wire rope vs the right-hand side drum rope which has yet to pass through the cleaner and Viper WRL.
